## **Saab 900 Convertible Top Replacement**

as performed March 2007 on a 1991 900 turbo  
by M.D.O., Hillsborough NC

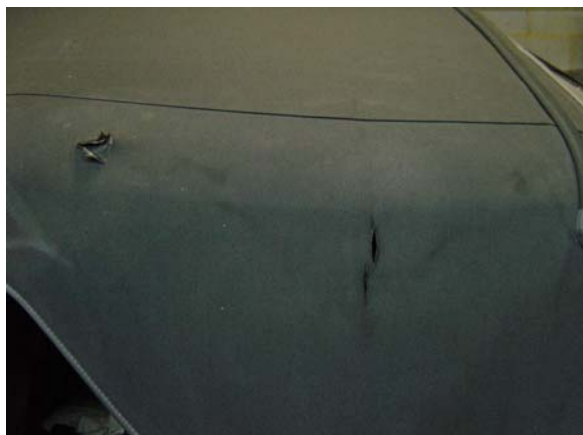
**Figure 1: Tears on sides of old top**

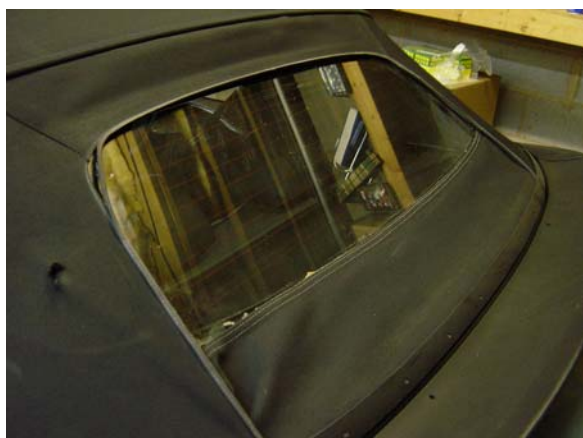
**Figure 2: Rear glass separated from old top plus another hole on side**

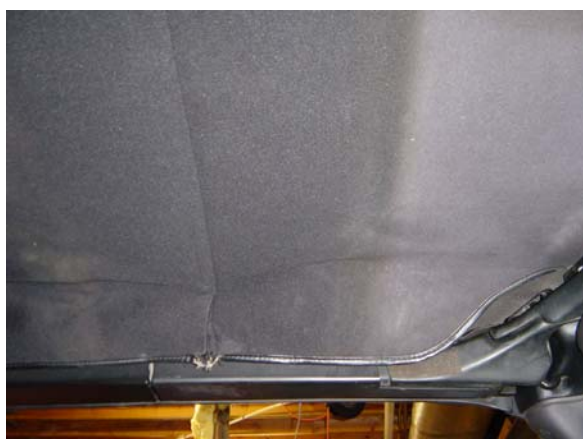
**Figure 3: Torn/faded headliner of old top**

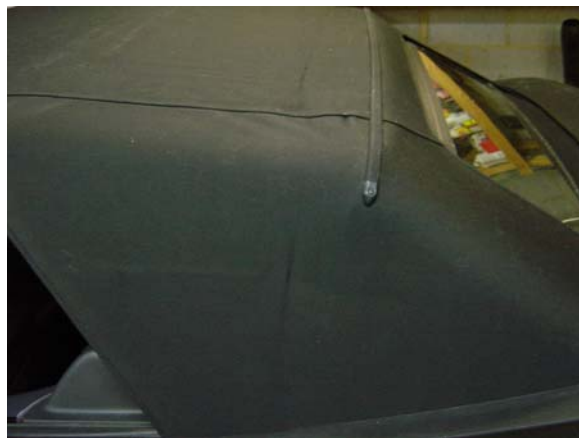
**Figure 4: There is a little slack I was unable to eliminate in the seams near the corners of rear bow, but this is minor. If it bothers you, buy the German top.**

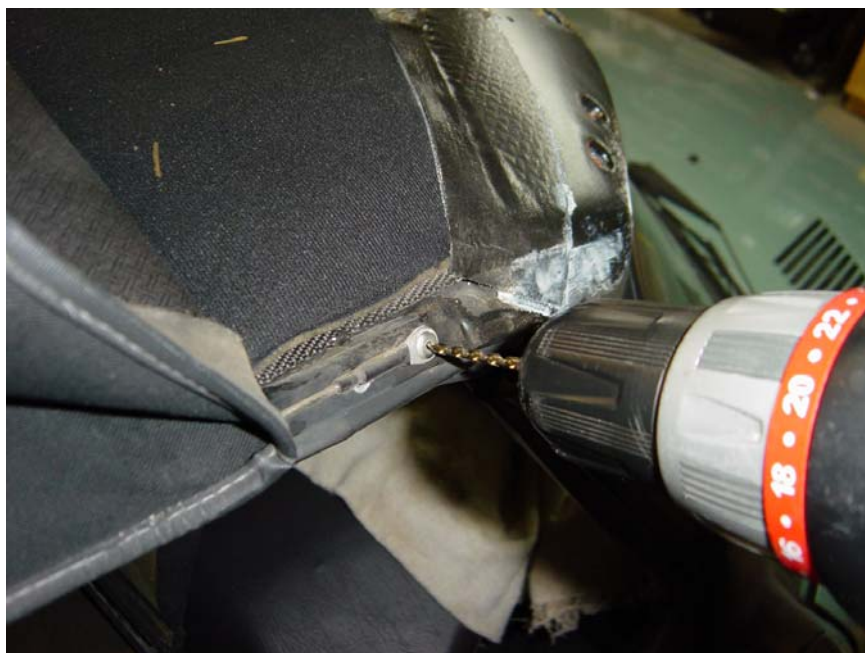
**Figure 9:** Drilling out pop rivets that hold the side cables at the front corners of the top. I started with 1/8" and finished with 9/64, then used a dental like tool to clean out the old rivet parts from back side of the hole. There is some black caulking that gets messy here – use adhesive remover to clean your hands and tools.

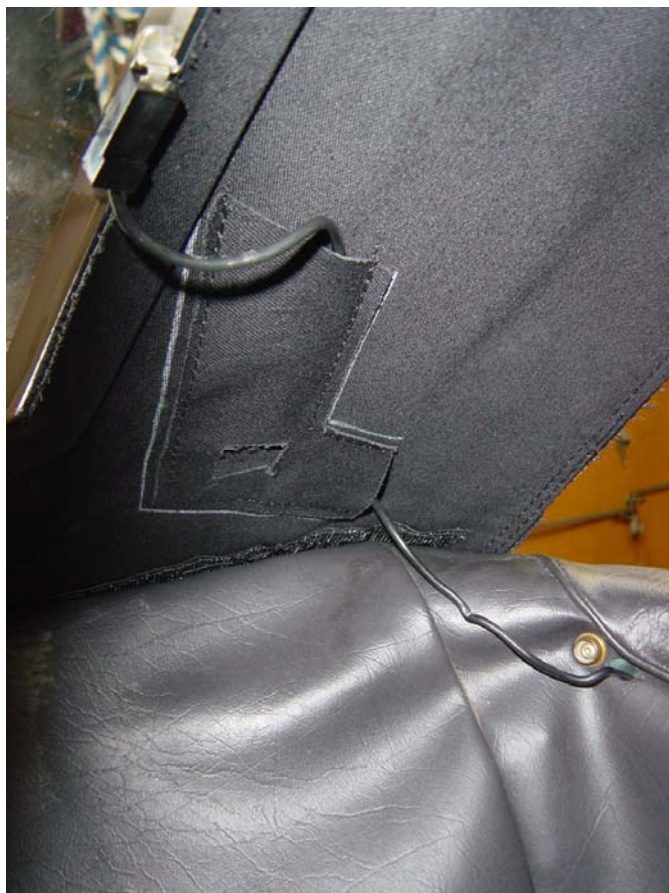
**Figure 37: Snake the defroster wire thru the fabric. Note the Velcro for the headliner is partially hidden under the stapled area. This is another indicator I had the rear window section too low, but at this point I had already trimmed the excess fabric so I added self adhesive Velcro above the original Velcro.**

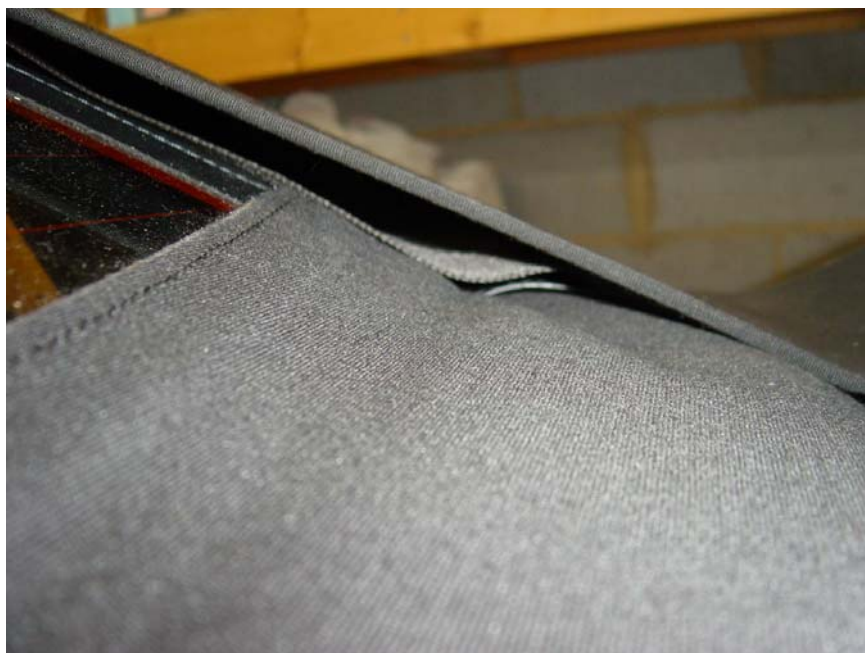
**Figure 41:** Here is a problem -- the tension of the new top when closed caused the rear window and the support strap above it to be loose. You can't know whether this will happen to you, just anticipate the top fitting will take extra time. I disassembled the rear section to retension the rear window and support strap.
